**Thank you for purchasing your new GMPP 19212712 clutch kit
Read these instructions carefully before you install your clutch kit.**

Due to the high failure rate of cylinders we have composed these instructions to help you with your clutch install.

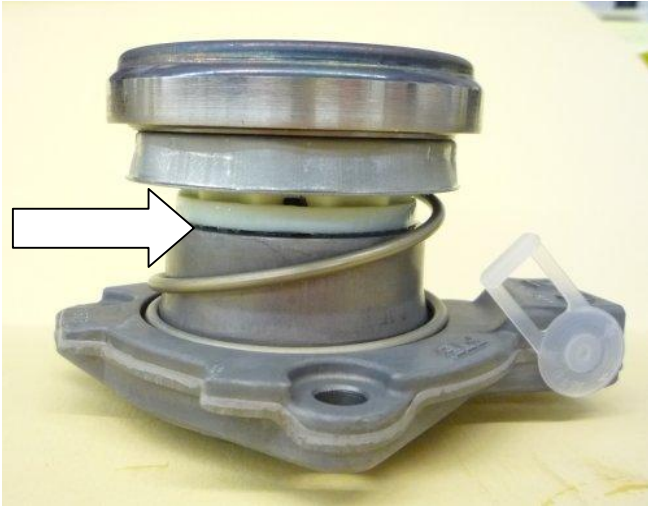
Image 1:

Please note that the black seal that the arrow is pointing to in **image 1** is only showing that much. Any more of the seal showing means the cylinder has been extended beyond its normal length of travel and should not be used.

New Slave Cylinder (Throw out bearing)

Note: arrow pointing to seal (we will discuss this later in more detail, but this is the maximum amount of seal that should ever be seen)

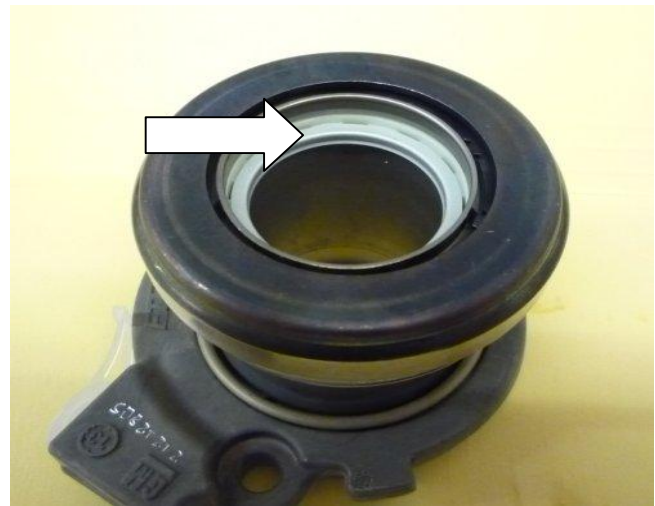
Image 2:

New Slave Cylinder Top view

Note: the top retaining ring (light grey in color) as shown in the two images one above and one below. The top edge of it should be smooth and with out any ripples

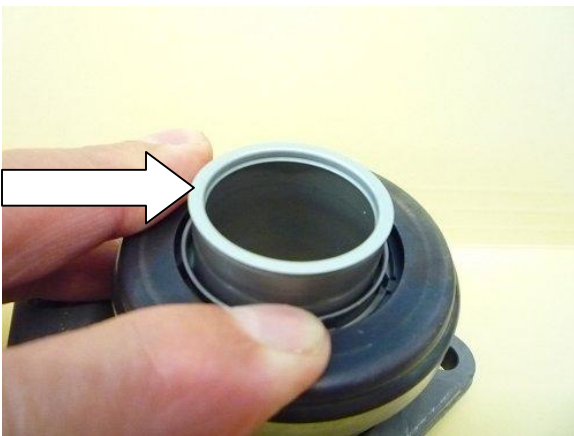
Image 3:

Top of slave cylinder compressed to show retaining ring. Note how smooth and flat the retaining ring is the arrow is pointing to

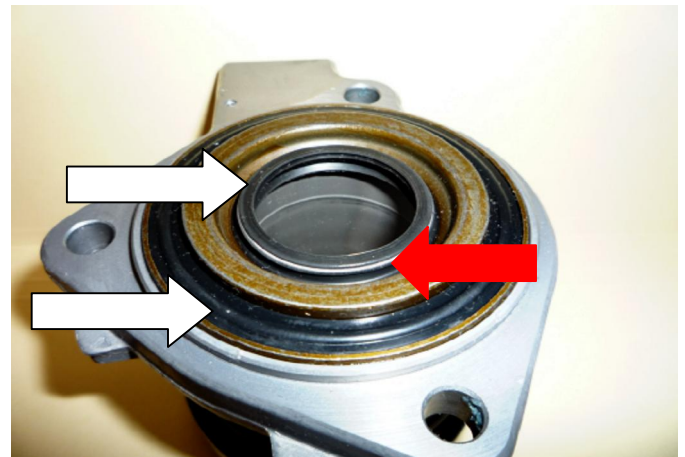
Image 4:

Bottom view of the new Cylinder
Inspect to see that both seals (White arrows) and seal spring (shown in red) are installed and are clean and free of any cuts or dirt.

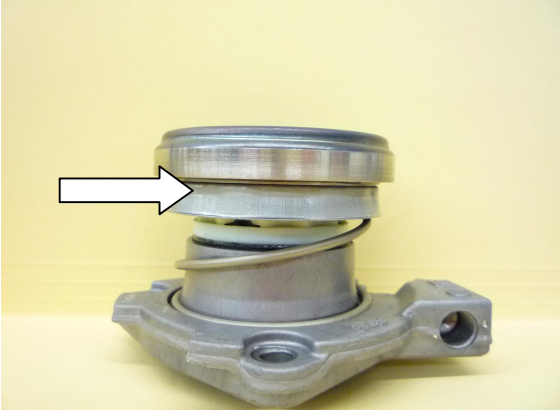
Image 5:

This cylinder has been damaged from being bench bled. Note how much more of the seal that is exposed than the one in image 1, it may seem like there isn't much more seal showing but that's all it takes for it to leak.

Do not try to pre bleed your cylinder before you install it as any excessive pressure used on the cylinder will cause it to bend the retaining ring and let the bearing assembly travel too far causing the seal to leak. Bleeding instructions are also included with the kit.

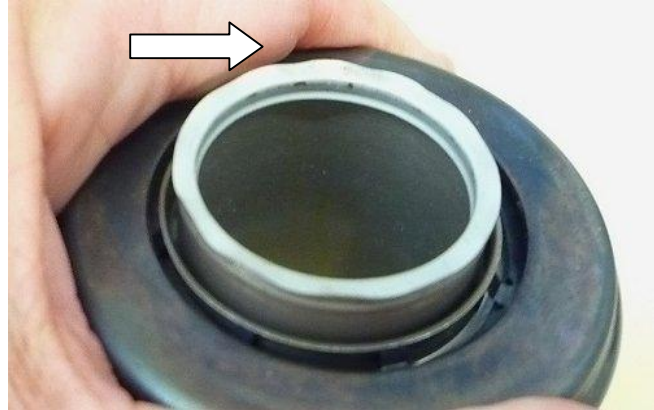
Image 6:

Note how the retaining ring is distorted and rippled. What happened here is the bearing section of the cylinder has been forced beyond its normal stopping point bending the retaining ring. Notice the ripple effect caused by the white piston shoulder. To help explain this look at the next image

In this case because the cylinder was not installed when they pressurized it, the bearing section pushed against the retaining ring distorting it and letting the seal travel beyond the normal accepted travel area.

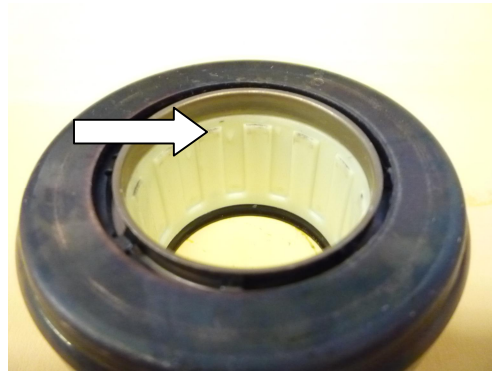
Image 7:

These shoulders that the arrow is pointing to are what the retaining ring sits against when fully extended. The only time the cylinder would ever be extended to the retaining ring is when not installed in a vehicle. If the piston part of the cylinder is forced beyond the normal travel the retaining ring will distort as it did in image 6. When that happens the seal extends too far out from the cylinder and you get a leak, see image 5 for a seal that is has traveled too far.

This may also be happening to customers who have had their flywheel cut and machined causing the TOB to have to travel beyond its normal accepted travel area.

We do not recommend cutting the old flywheel as this may cause the slave cylinder to have to travel further than its normal intended amount.

If the old flywheel needs to be cut you should replace it with a new flywheel Part number 12584343.
