#10-06-02-001: Engine Over Heat/Poor Heater Performance (Install Two Valve in Cooling System) - (Feb 4, 2010)

Subject: Engine Over Heat/Poor Heater Performance (Install Two Valves in Cooling System)

Models: 2007-2009 Pontiac Solstice GXP 2007-2009 Saturn SKY Redline 2007-2009 Opel GT 2007-2009 Daewoo G2X All Equipped With RPO LNF

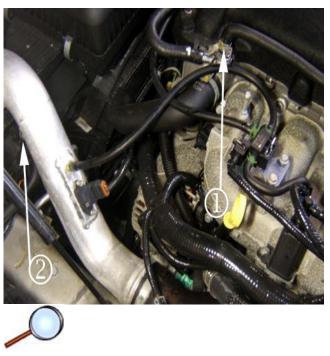
- 2. With a cold cooling system, lower the coolant level enough that when removing the coolant return hoses from the cylinder head and radiator return ports coolant will NOT leak on to the ground or on surrounding components. Prior to removing the hoses, place shop towels around the bottom of the ports to absorb any lost coolant.
- 3. Remove the coolant return hose from the engine port. Carefully remove the clamp from the hose and set aside the clamp will be reused in the final step of installing the hose.

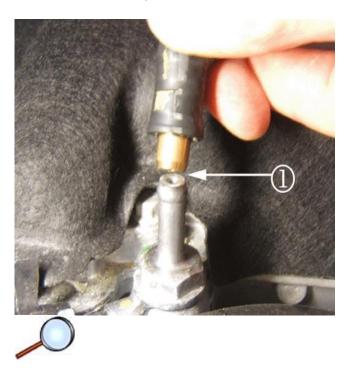
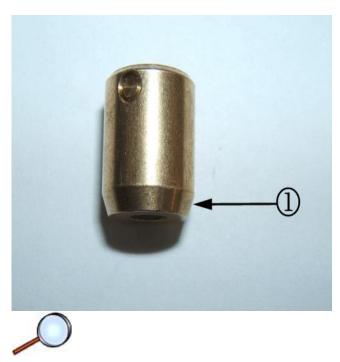
- 4. Using a non-silicon based tire lubricant, lightly coat the check valve (P/N 20876185) and insert it in to the engine return hose (1) 15 mm (0.5 in) in the hose with the tapered end pointing toward the nipple that is on the engine (1).
- 5. Press the hose on to the nipple and seat the hose to the base of the fitting (1). This will push the check valve further in to the hose, resulting in a slight bulge in the hose in the middle of the bend. The valve should not be pushed in the hose to the point that it is in the horizontal position. A check valve in the horizontal position will not function properly.
- 6. Remove the hose. Install the hose clamp on the hose and reinstall the hose.

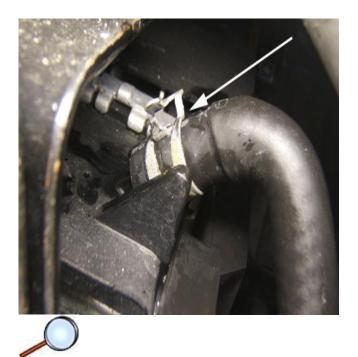
Important: The tapered end of the check valve must face the nipple on the radiator. A check valve in the horizontal position will not function properly.

7. Remove the coolant return hose from the radiator. Carefully remove the clamp from the hose and set aside – the clamp will be reused in the final step of installing the hose.

- 8. Using a non-silicon based tire lubricant, lightly coat the check valve (P/N 20876185) and insert it in to the radiator hose return line 15 mm (0.5 in) in the hose with the tapered end pointing toward the radiator nipple. Press the hose on to the nipple and seat the hose to the base of the fitting. This will push the check valve further in to the hose resulting in a slight bulge in the hose.
- 9. Remove the hose. Install the hose clamp on the hose and reinstall the hose on the radiator return.
- 10. Add coolant to the "Full Cold" line of the bottle. To purge any air from the system, use the vac-n-fill process per SI.
- 11. Inspect the cooling system for leaks.
- 12. Rinse away any excess coolant from the engine and the engine compartment.
